## MAINTENANCE

# HYDRAULIC DIAGRAM

## EXPLODED VIEWS & PARTS LISTS

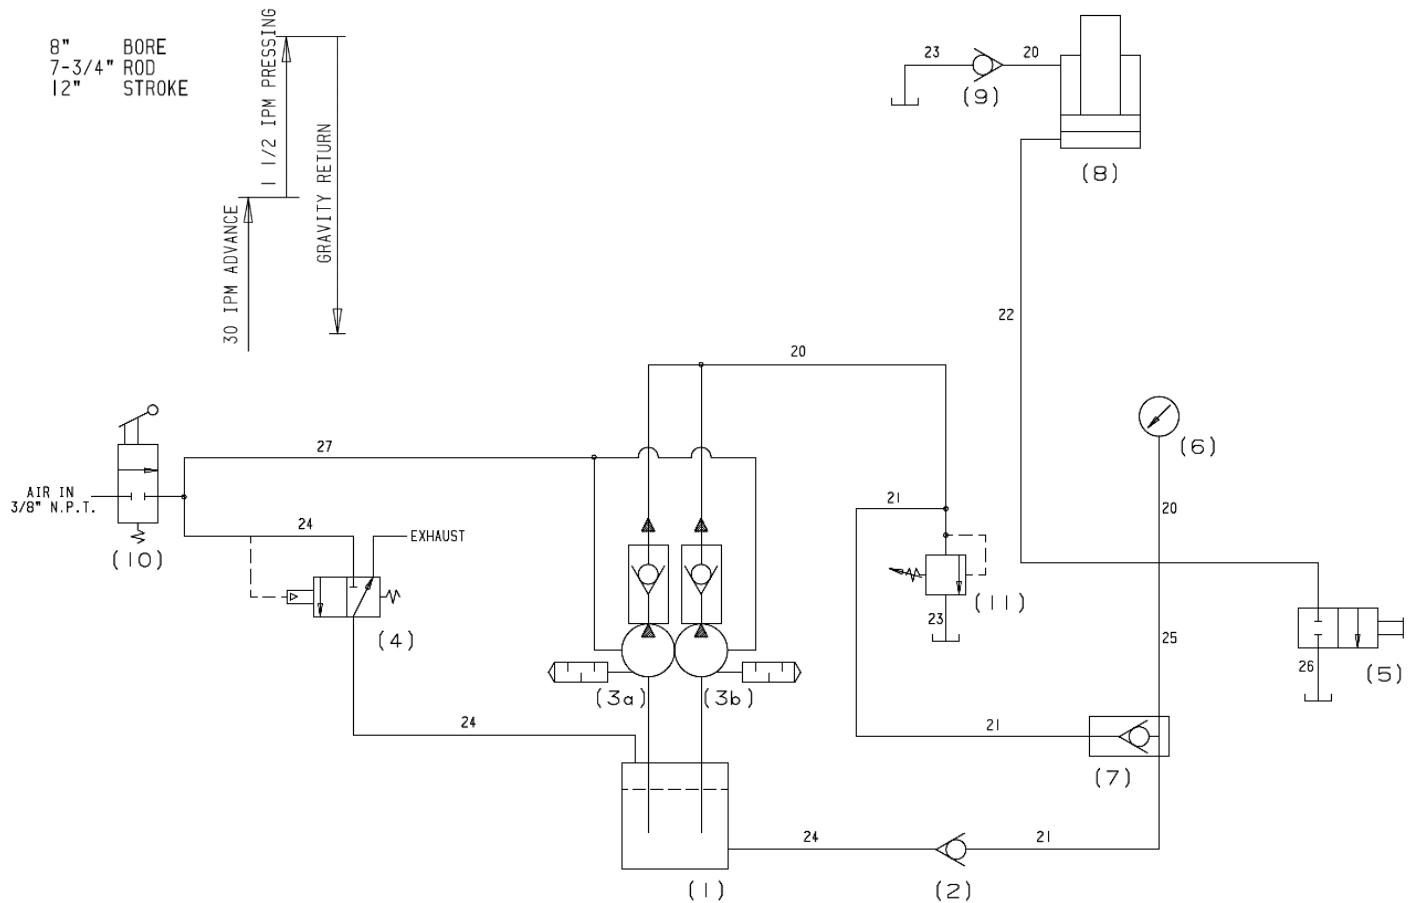
C.F.M. REQUIREMENT 25.0 MAX. NO LOAD
